**CITY OF SAN LUIS OBISPO  
CULTURAL HERITAGE COMMITTEE STAFF REPORT**

**PROJECT ADDRESS:** Citywide (CHC 48-11)

**SUBJECT:** Continued study session to review program for updating the City's Historic Resource Inventory.

# Historic Resource Survey Field Photo Inventory

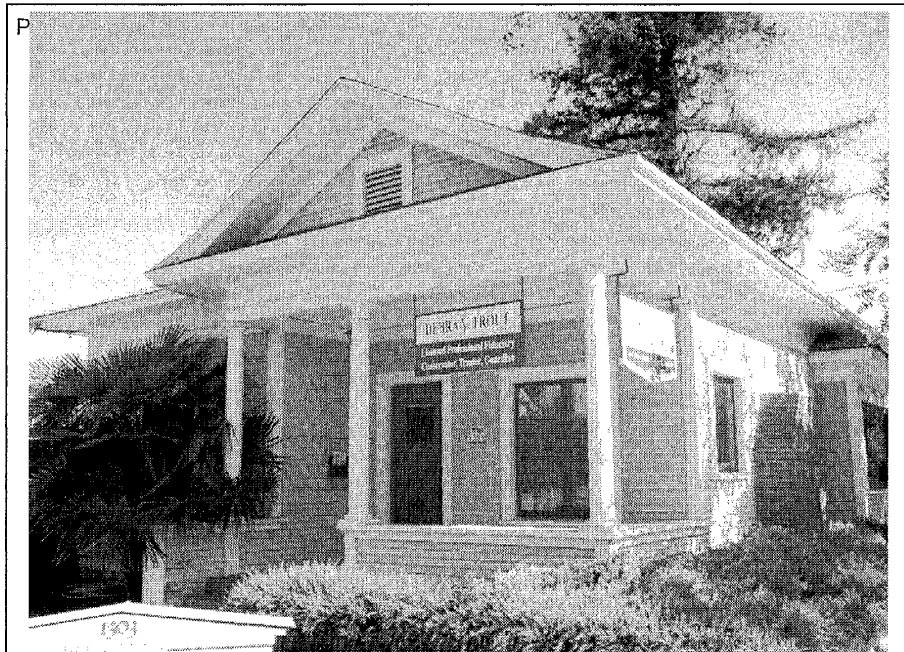
c. Address 1303 Higuera Street City San Luis Obispo Zip 93422

This 1908 rectangular Colonial Bungalow has an offset front facing gable sheathed in shiplap siding with a rectangular vent. The medium pitch hipped roof flattens slightly when it flares out over the eaves. The open porch is supported by 3 colonial style rounded columns. The centrally located door is wood with a small window. The base of the chimney remains on the Johnson Avenue elevation but the upper portion has since been demolished. The fixed windows appear to have been updated to accommodate office use. The house is in good condition and landscaped. A large redwood tree dominates the rear yard.
